## CO2 Flow, Alteration And Geomechanical Response In Confining Units – An Experimental Approach

E. Skurtveit<sup>1,2\*</sup>, A. Sundal<sup>2</sup>, M. Soldal<sup>1</sup>, G. Sauvin<sup>1</sup>, T.I. Bjørnarå<sup>1</sup><sup>1</sup>NGI (Norwegian Geotechnical Institute), <sup>2</sup>UiO (University of Oslo)

### Summary

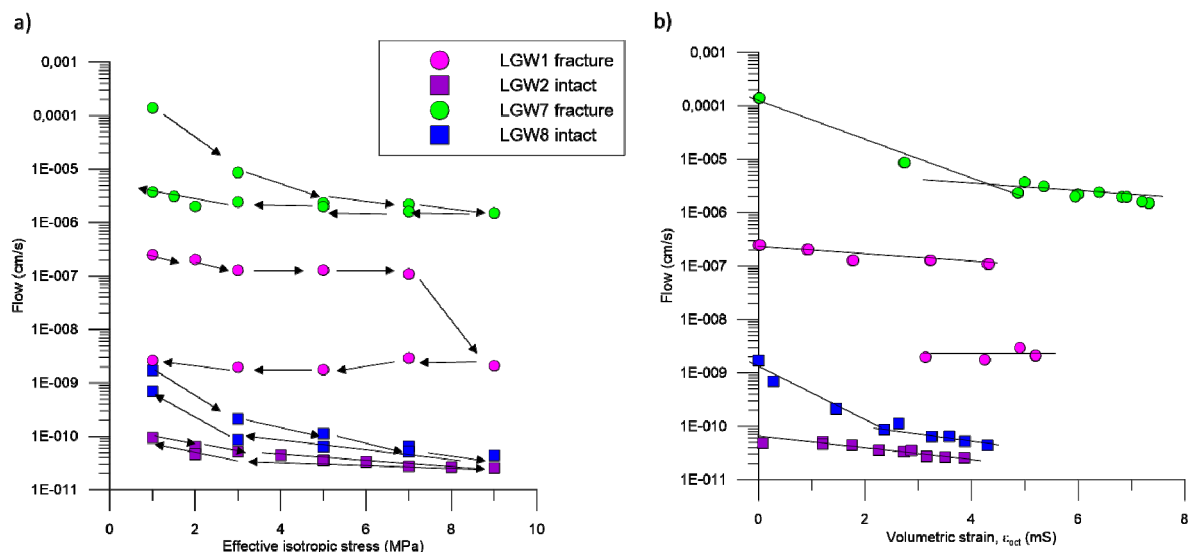
**Figure 2** Measured stress-dependent flow as a function of effective isotropic stress (a) and volumetric strain (b) for fractured and intact sample. Arrows show loading direction in (a). In (b) trend lines are added to highlight the initial fast decrease in flow rate with strain for the fractured and intact bleached siltstone (LGW7 and LGW8) compared to the red siltstone where the decrease in flow rate with strain is slower.

The experimental program provides useful insight into effects of alteration of both host rock and fractures. From the 9 MPa loading cycle, systematic changes in stress dependent flow properties are observed (Figure 2a). From 2 to 5 orders of magnitude higher flow rates are found for the fractured samples compared to the host rock. The largest difference is observed for the altered samples (LGW7 and LGW8). The wide, altered fracture in sample LGW7 shows 1 to 3 orders of magnitude higher flow rates compared to the thin, unaltered fracture in sample LGW8. A strong reduction in fracture flow is observed for the loading up to 9 MPa, whereas the unloading is associated with less variation. This hysteresis effect is more pronounced for the altered samples than for the unaltered samples. This seems to be the case for both the fractured sample and the host rock. In the plot of flow against volumetric strain (Figure 2b), flow and strain correlate for both the loading and unloading phase except for the unaltered fracture test (LGW1), where an abrupt reduction in flow is associated with the last loading step (from 7 to 9 MPa). The two altered samples (host rock and fracture) stand out with a very high reduction in flow associated with the first 2 to 4 mS of deformation before approaching the same trend as for the unaltered samples LGW1 and LGW2 (Figure 2b). Two different trends are observed for the stress dependency of the fracture stiffness (Figure 3a) and S-wave velocity (Figure

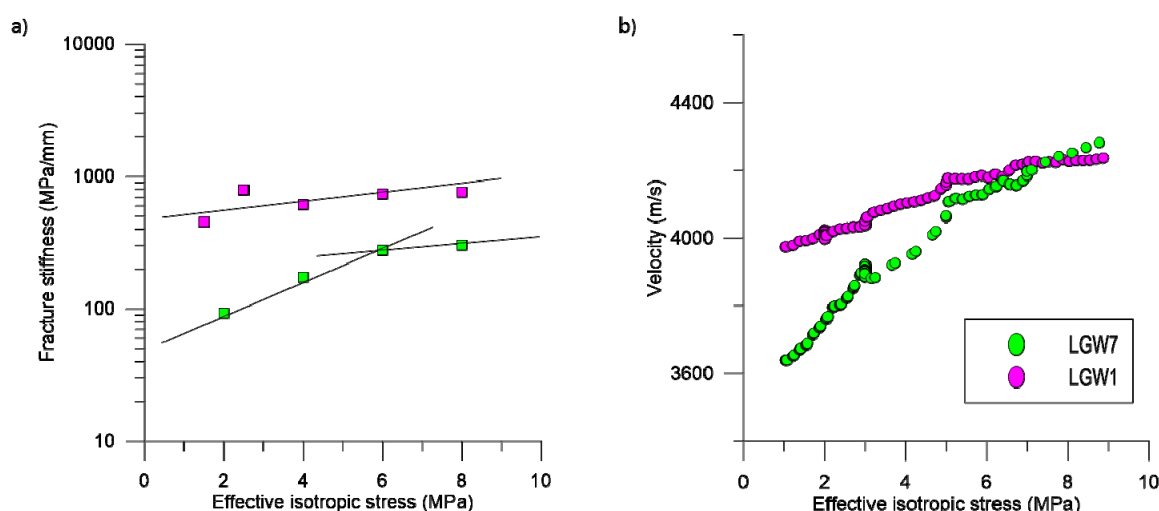
**Figure 3** Fracture stiffness,  $K_n$ , defined as  $d\sigma/d\epsilon_f$  (a) and radial S-velocity (b) for the fractured red siltstone (LGW1) and the bleached siltstone (LGW7) showing a marked change in trend during loading (closure) of the bleached siltstone fracture compared to the red siltstone.

3b) for the altered fractured sample (LGW7), whereas for the unaltered fractured sample (LGW1) the measurements follow a linear trend.
